> Project 672648 30 October 2014 SB/BWE

Level 1 Earthworks Quality Report 250 – 292 Spring Mountain Drive, Greenbank

This report presents the results of inspection and testing of the bulk earthworks for Lot 7, Spring Mountain Drive, Greenbank.

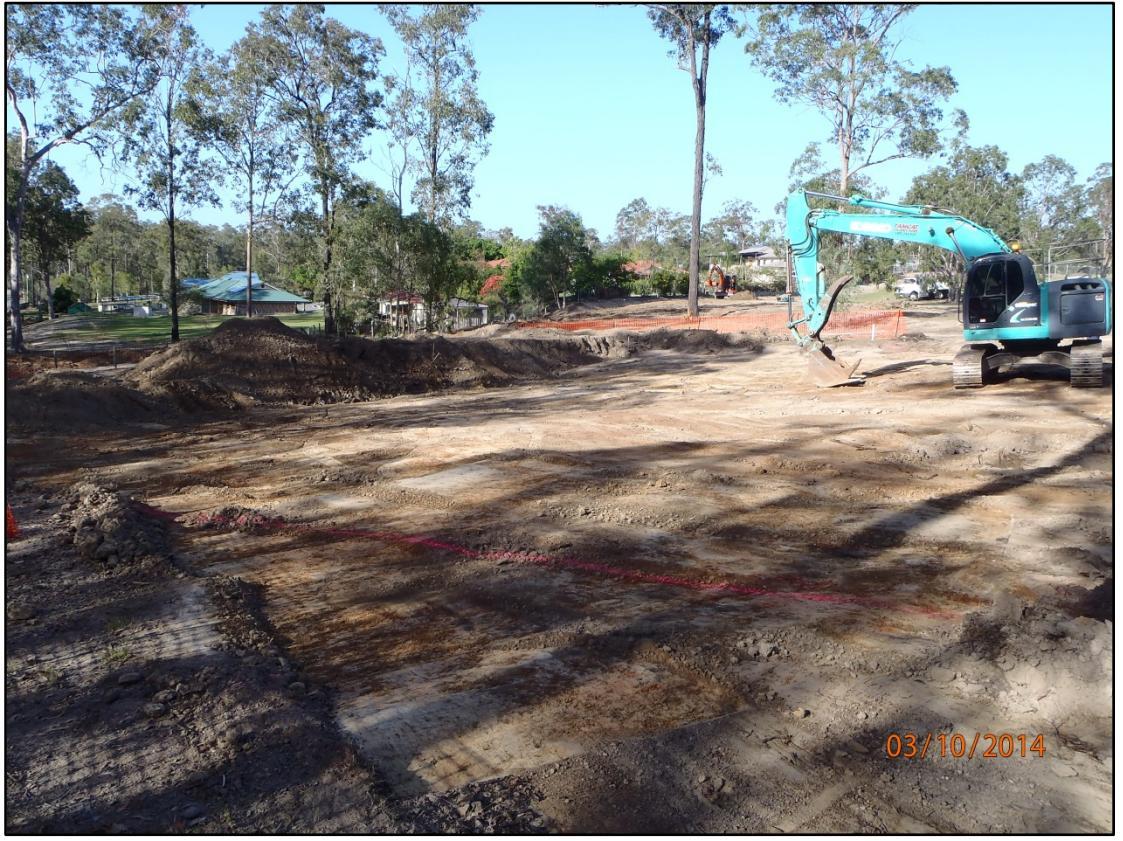
The filling area was initially stripped of vegetation and topsoil that was present. The exposed subgrade generally comprised very stiff sandy gravelly clay. Prior to the placement of any new filling, test rolling of the exposed subgrade was performed using a fully loaded 10,000 litre water truck. Any areas identified as "soft spots" were excavated to a suitable subgrade, showing no signs of movement before backfilling commenced.

Figure 1: Subgrade preparation across building platform, facing south
