Qualtest Laboratory

**RE: REPORT ON CONTROLLED FILLING
 LOT 906 – EDEN’S CROSSING STAGE 27, 28 AND 29
 REDBANK PLAINS**

LEVEL ONE EARTHWORKS REPORT

**Proposed Residential
Subdivision
Eden's Crossing Stages 27, 28 &
29**

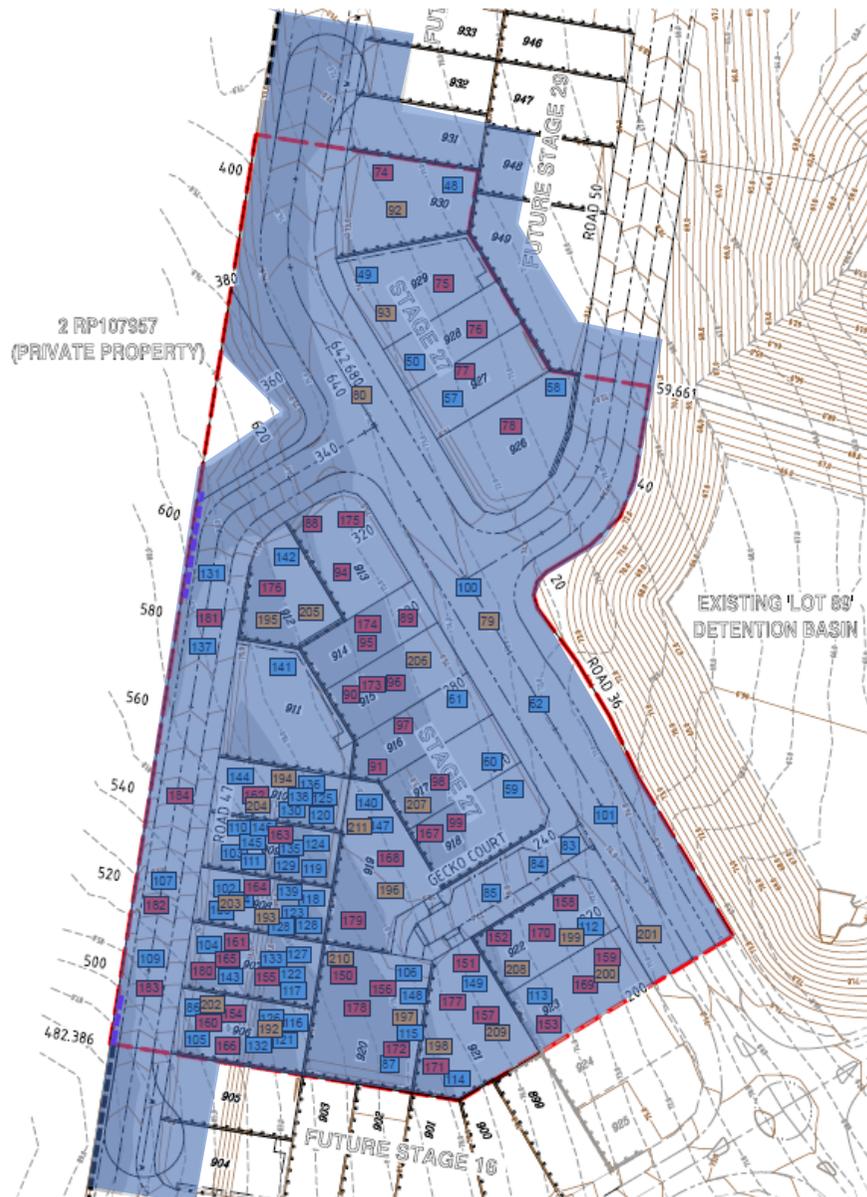
DRAWING NO: 23-021-01

Based on the test results and site inspections, Qualtest concludes that the fill on Lot 906 to the extent shown as Figure 1 below has been constructed in general accordance with the project requirements and AS3798.

The fill in the area defined on Figure 1, within the time frame of our inspection and testing program, is considered to be Controlled Fill as defined in AS2870 “*Residential Slabs and Footings*”.

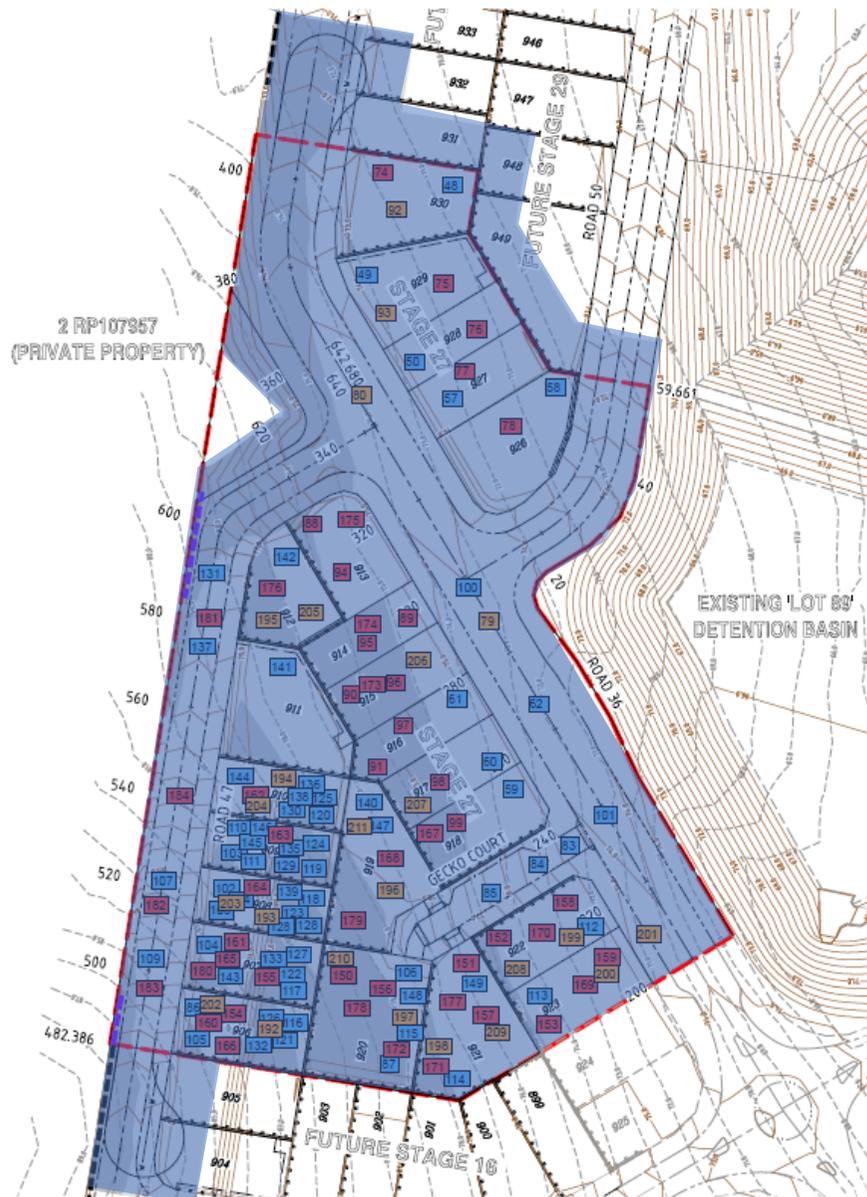
DRAWING NO: 23-021-01

Based on the test results and site inspections, Qualtest concludes that the fill on Lot 907 to the extent shown as Figure 1 below has been constructed in general accordance with the project requirements and AS3798.

The fill in the area defined on Figure 1, within the time frame of our inspection and testing program, is considered to be Controlled Fill as defined in AS2870 “*Residential Slabs and Footings*”.

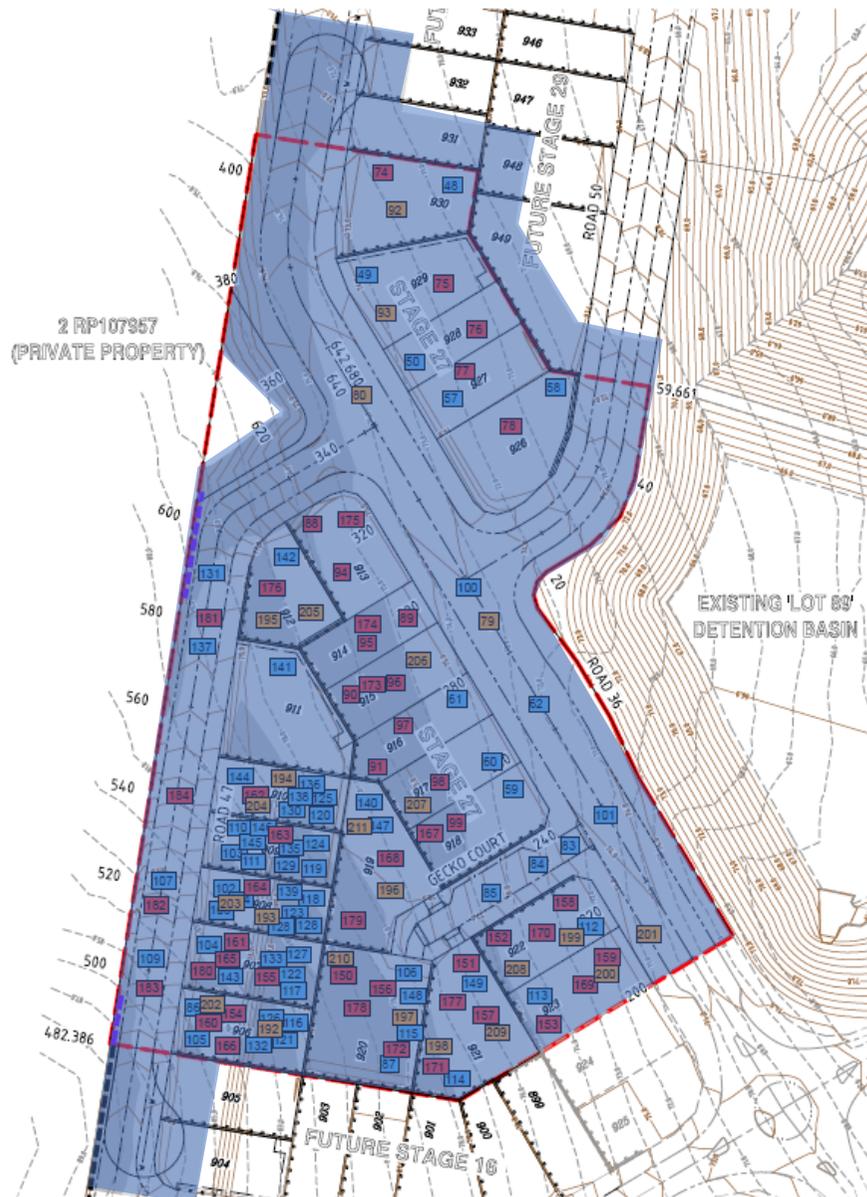
DRAWING NO: 23-021-01

Based on the test results and site inspections, Qualtest concludes that the fill on Lot 908 to the extent shown as Figure 1 below has been constructed in general accordance with the project requirements and AS3798.

The fill in the area defined on Figure 1, within the time frame of our inspection and testing program, is considered to be Controlled Fill as defined in AS2870 “*Residential Slabs and Footings*”.

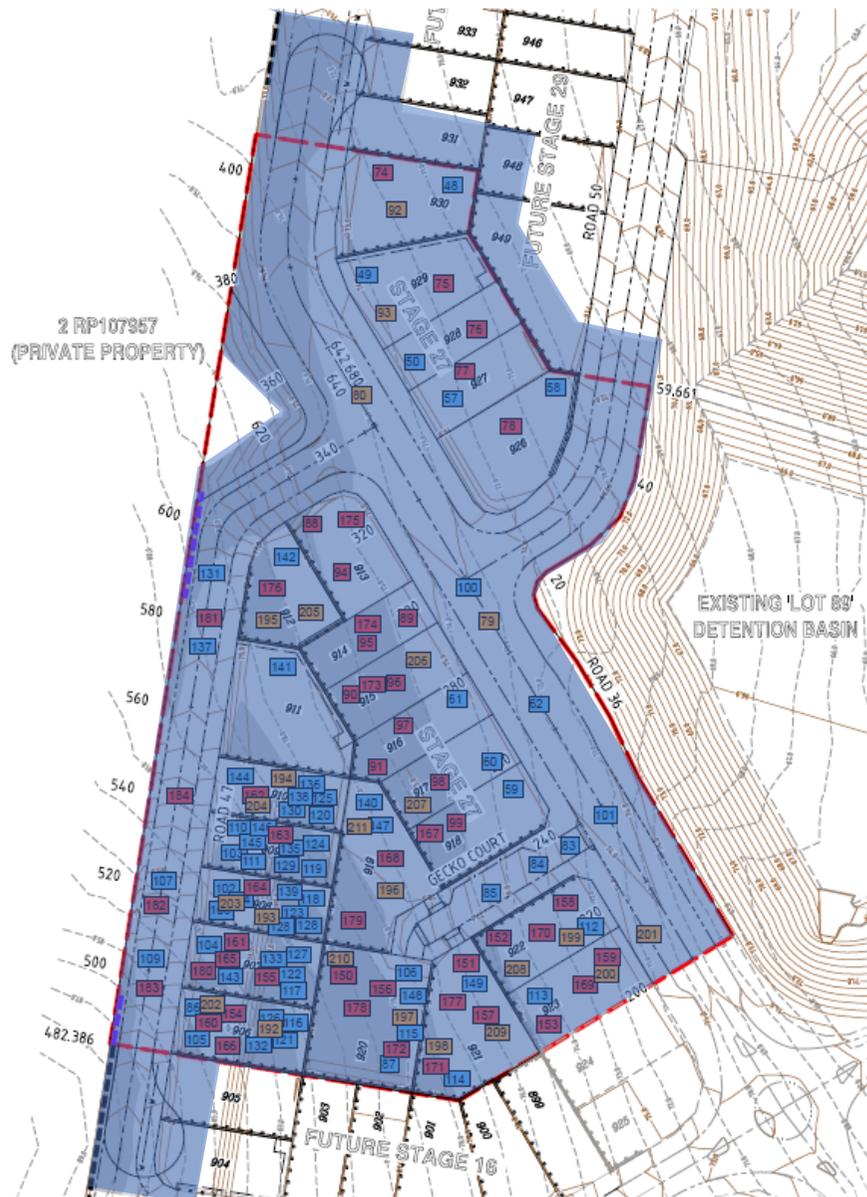
DRAWING NO: 23-021-01

Based on the test results and site inspections, Qualtest concludes that the fill on Lot 909 to the extent shown as Figure 1 below has been constructed in general accordance with the project requirements and AS3798.

The fill in the area defined on Figure 1, within the time frame of our inspection and testing program, is considered to be Controlled Fill as defined in AS2870 “*Residential Slabs and Footings*”.

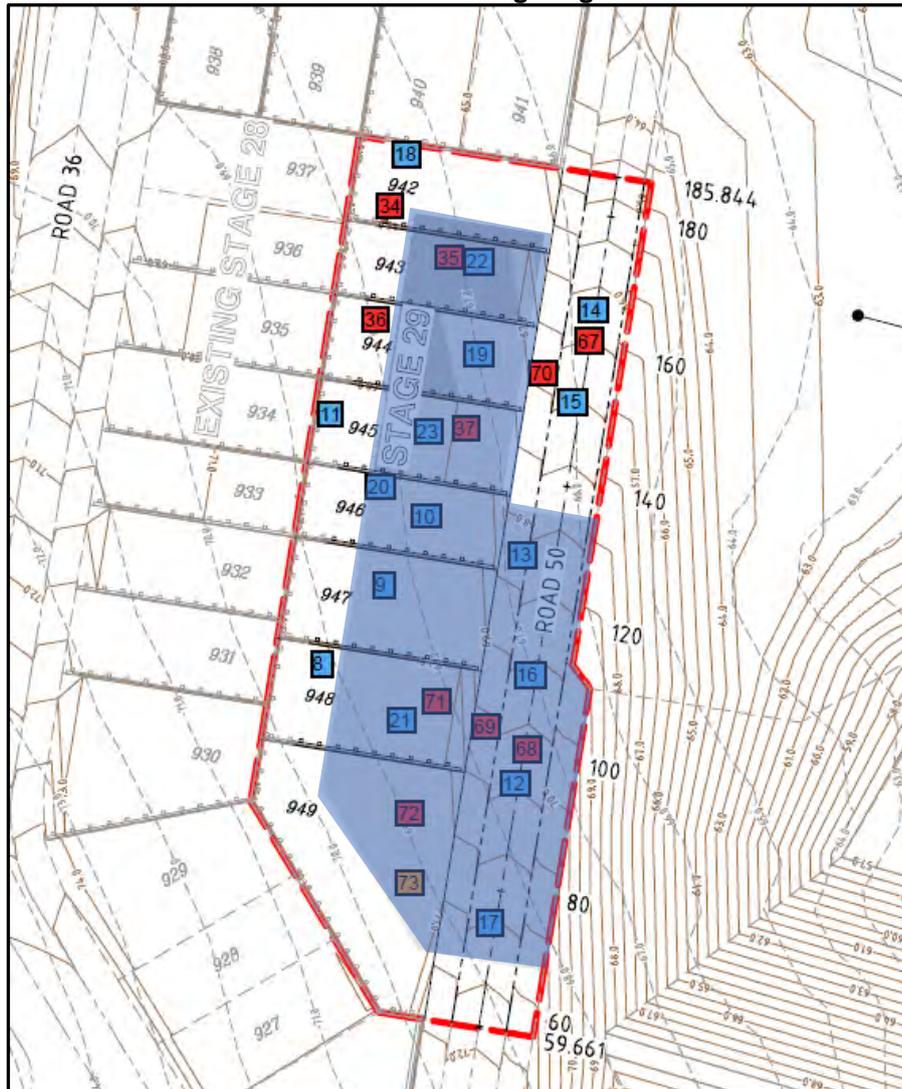
Figure 3: Bulk Earthworks Plan – Eden’s Crossing Stage 29 – Extent of Fill – Shaded Blue

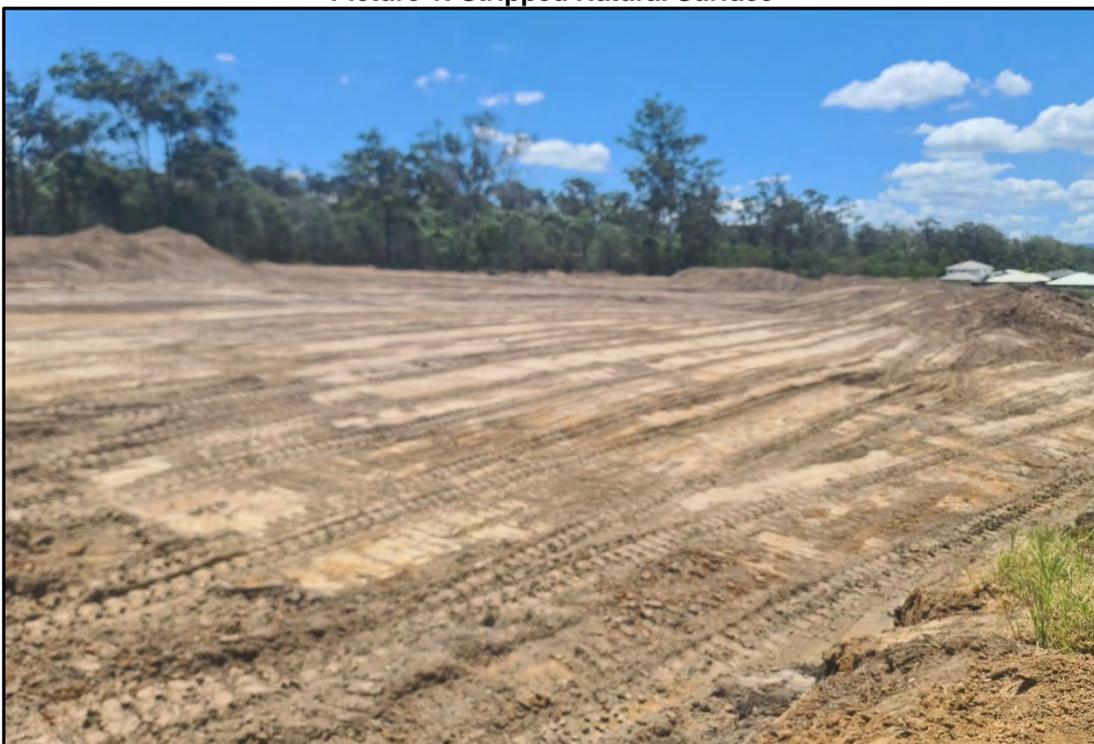
Areas to be filled at the site were observed to be stripped of vegetation, grass, redundant services, existing uncontrolled fill, water affected ground and topsoil to depths exposing competent natural ground.

- Adequate removal of topsoil, organics and existing fill to expose natural soils consisting of: -
 - Sandy Clay (SC), at least stiff, medium plastic fines, orange brown and moist.
 - Sandstone (XW), typically low strength, fine to coarse sands, grey brown.
- Compliant proof roll testing of the stripped surface using onsite earthworks plant.

Picture 1: Stripped Natural Surface

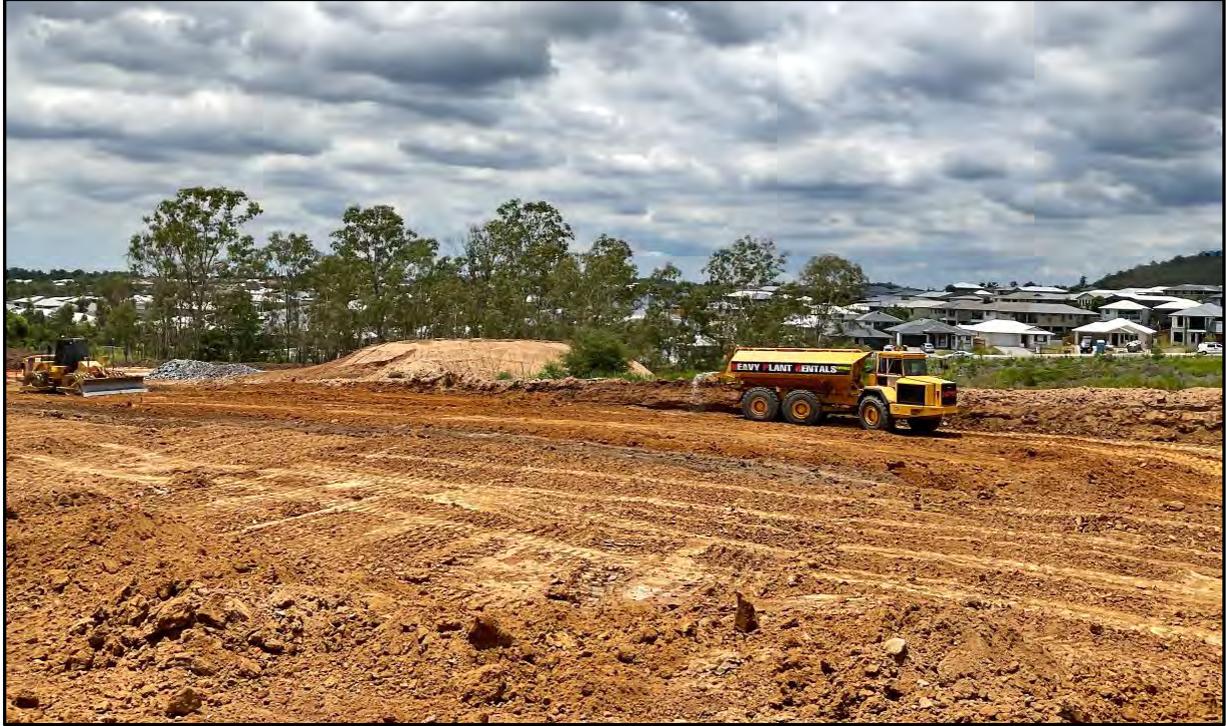
Picture 2: Filling Operations

Fill was observed to be placed in layers within the capacity of the above plant, appropriately moisture conditioned and compacted using several passes.
