**RE:                   REPORT ON CONTROLLED FILLING  
                          LOT 942 – EDEN’S CROSSING STAGE 27, 28 AND 29  
                          REDBANK PLAINS**

Fill was placed and compacted on Lot 942 in the Eden’s Crossing Stage 27, 28 and 29 Estate between 24<sup>th</sup> January 2023 and 31<sup>st</sup> March 2023 under Level One Inspections and Testing by Qualtest Laboratory.

Earthworks to be constructed at the site are presented on KN Group Consulting Engineers Drawings. A marked-up plan showing the extent of fill covered by this report is presented as Figures 1, 2 and 3 below.

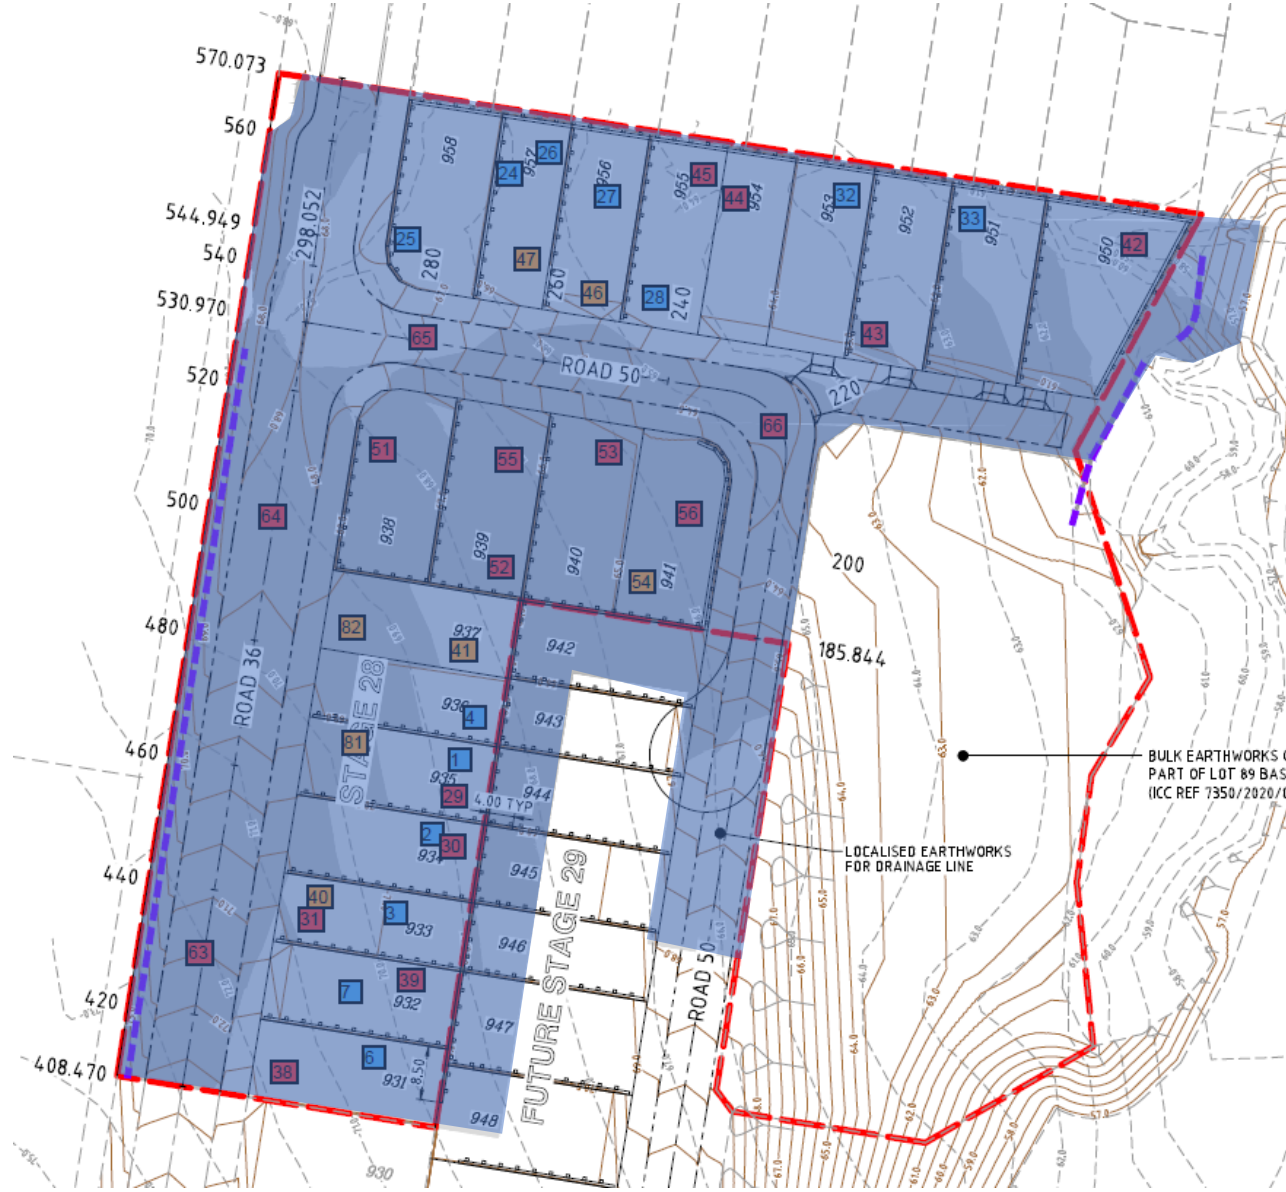
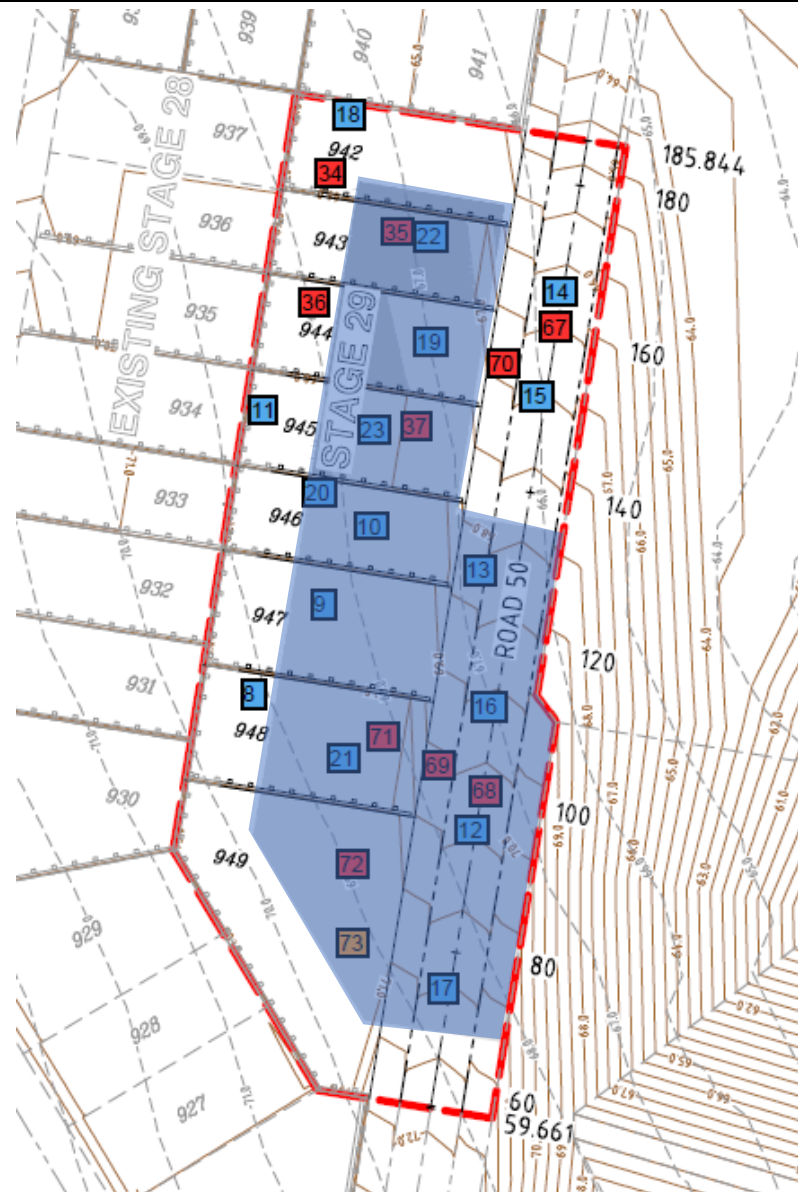
*Attached: Figure 1 – Site Plans showing test locations and approximate extents of Controlled Filling.*

Based on the test results and site inspections, Qualtest concludes that the fill on Lot 942 to the extent shown as Figure 1 below has been constructed in general accordance with the project requirements and AS3798.

The fill in the area defined on Figure 1, within the time frame of our inspection and testing program, is considered to be Controlled Fill as defined in AS2870 “*Residential Slabs and Footings*”.

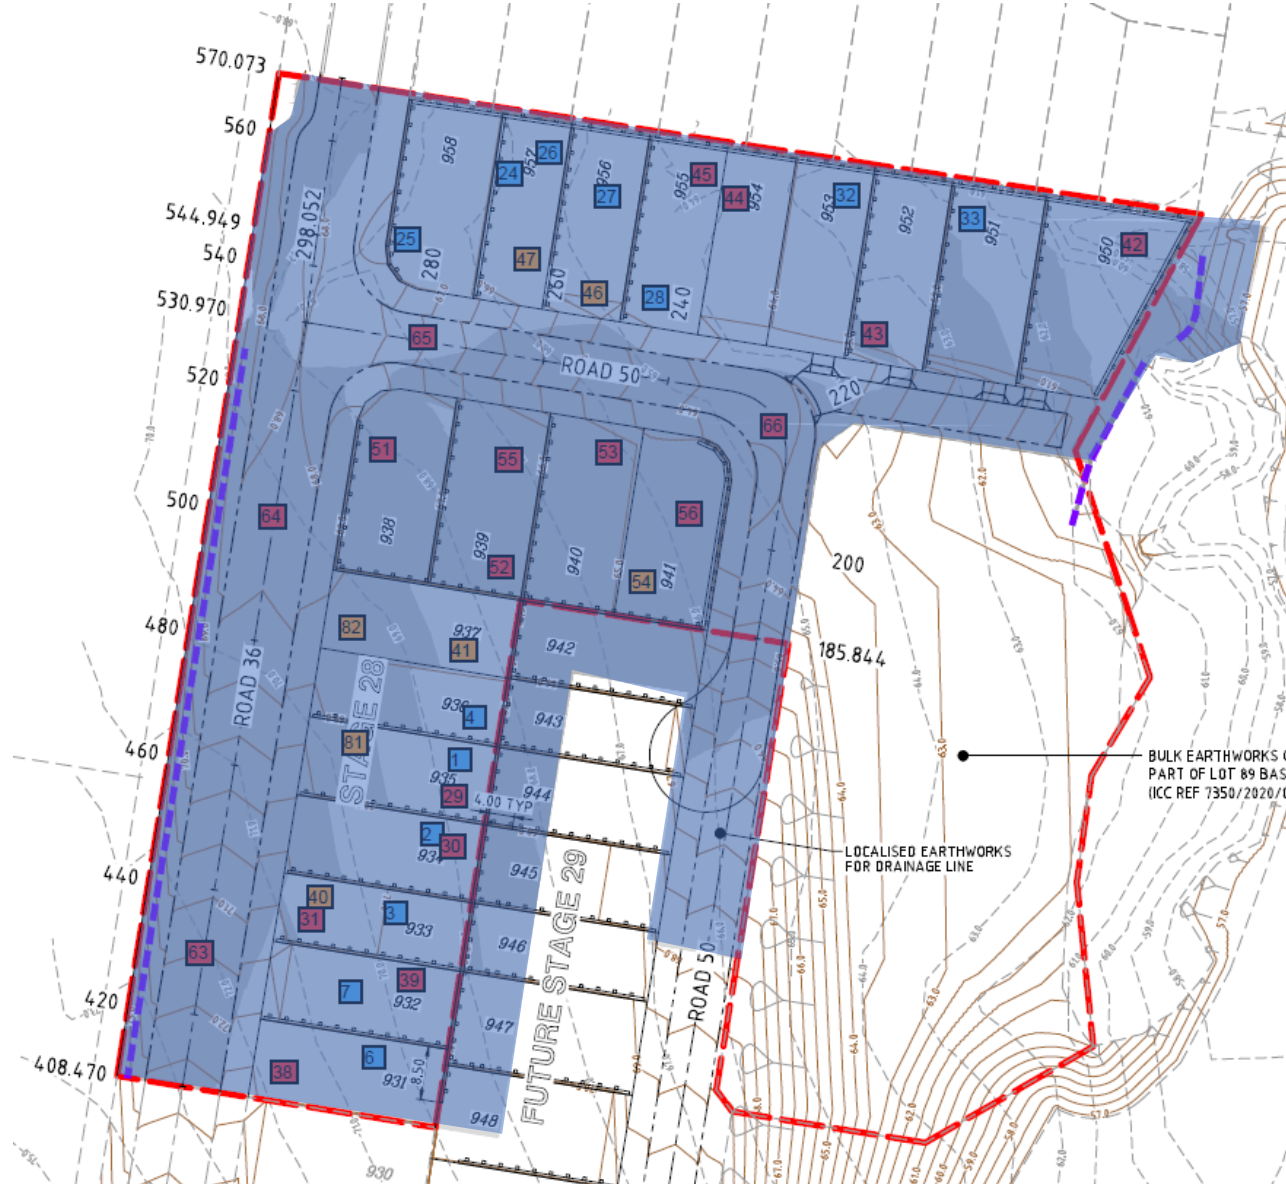
DRAWING NO: 23-021-02

Approximate Extents of Controlled Filling

TITLE: Compaction Test Location

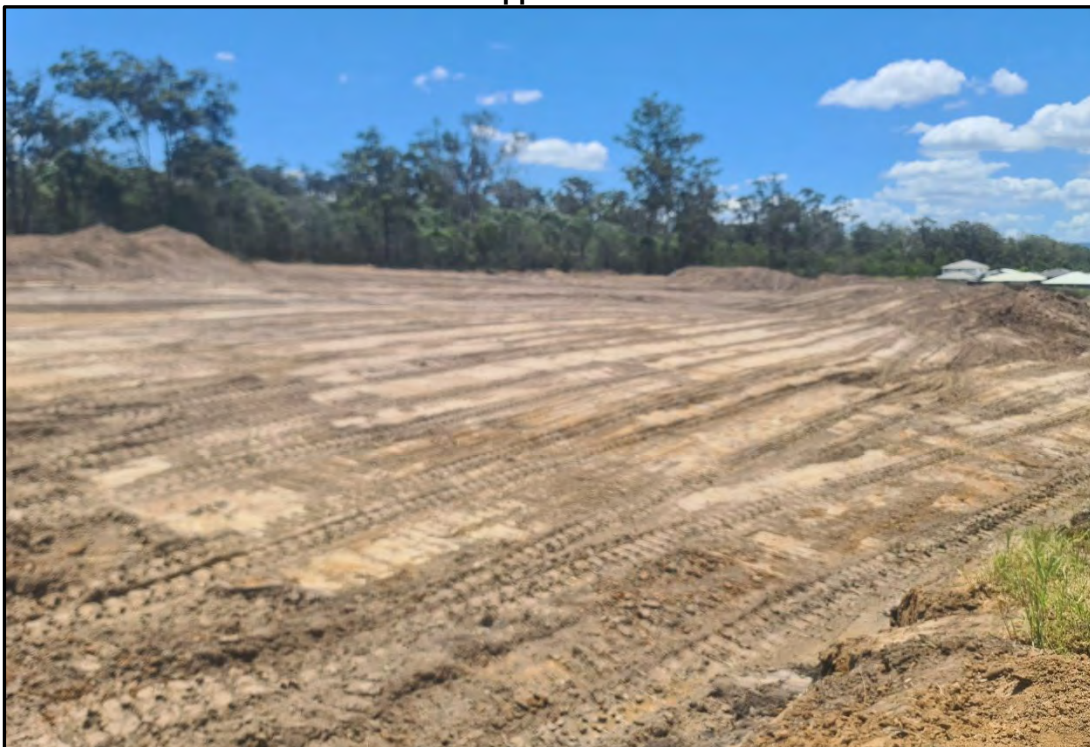
**Picture 1: Stripped Natural Surface**

Areas to be filled at the site were observed to be stripped of vegetation, grass, redundant services, existing uncontrolled fill, water affected ground and topsoil to depths exposing competent natural ground.

- Adequate removal of topsoil, organics and existing fill to expose natural soils consisting of: -
  - Sandy Clay (SC), at least stiff, medium plastic fines, orange brown and moist.
  - Sandstone (XW), typically low strength, fine to coarse sands, grey brown.
- Compliant proof roll testing of the stripped surface using onsite earthworks plant.

A picture of the stripped natural surface observed prior to filling are presented below.

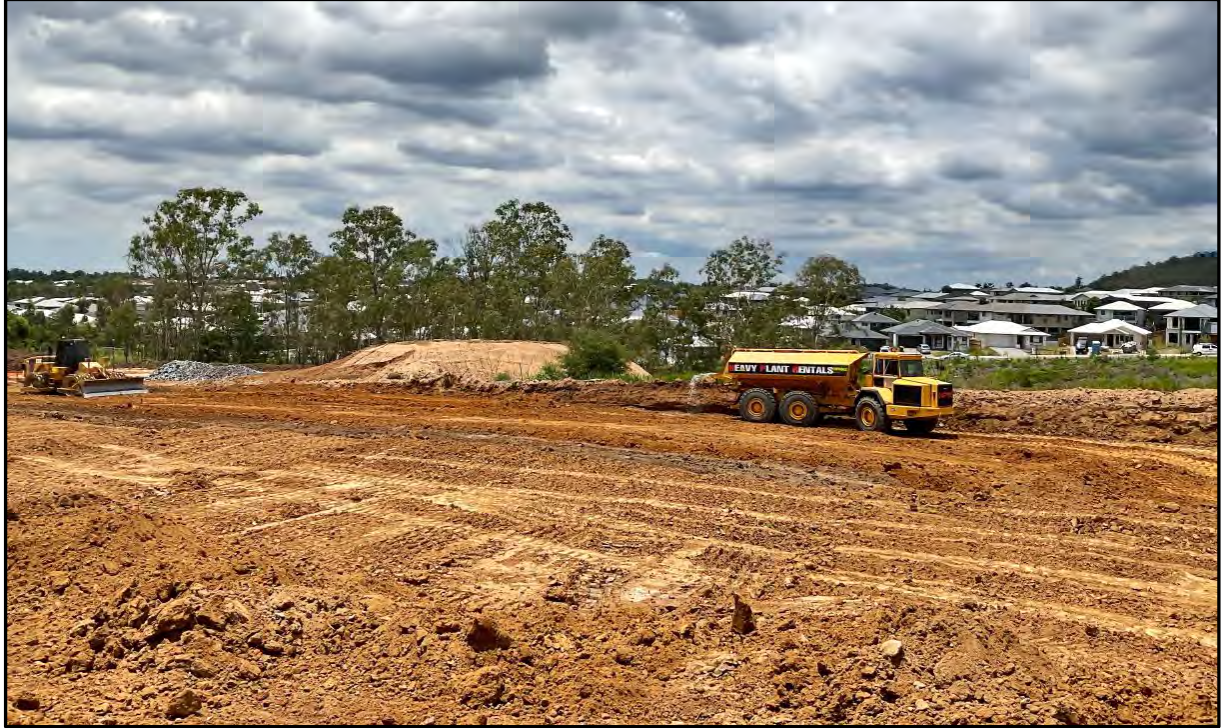
**Picture 2: Filling Operations**

Fill was observed to be placed in layers within the capacity of the above plant, appropriately moisture conditioned and compacted using several passes.

Pictures of the filling operations are presented below.
